REPORT OF CANINE INVESTIGATION OF HUMAN WASTEWATER CONTAMINATION

Maplewood Lake, Jenison, MI

Prepared For: Georgetown Township, MI

Report Date: August 1, 2016

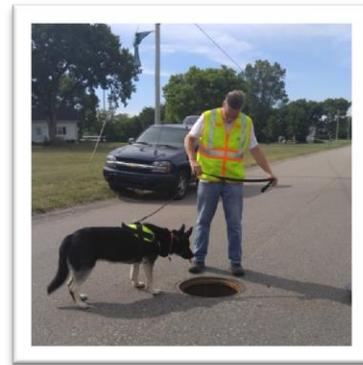
One canine alerted at the stormwater outfall on the southeast side of the lake and to the catch basin draining to it. Suds were visible inside the catch basin, indicating a possible discharge of detergents to that basin. It was noted that the resident of the house across the street from the outfall and catch basin was power washing carpets in his driveway. No suds were visible on the driveway, and the resident told ECS personnel that no detergents were being used. The suds may have originated from car washing or a similar activity using detergents at another residence along the street that flowed into the catch basins, which was the probable cause of the canine alert.

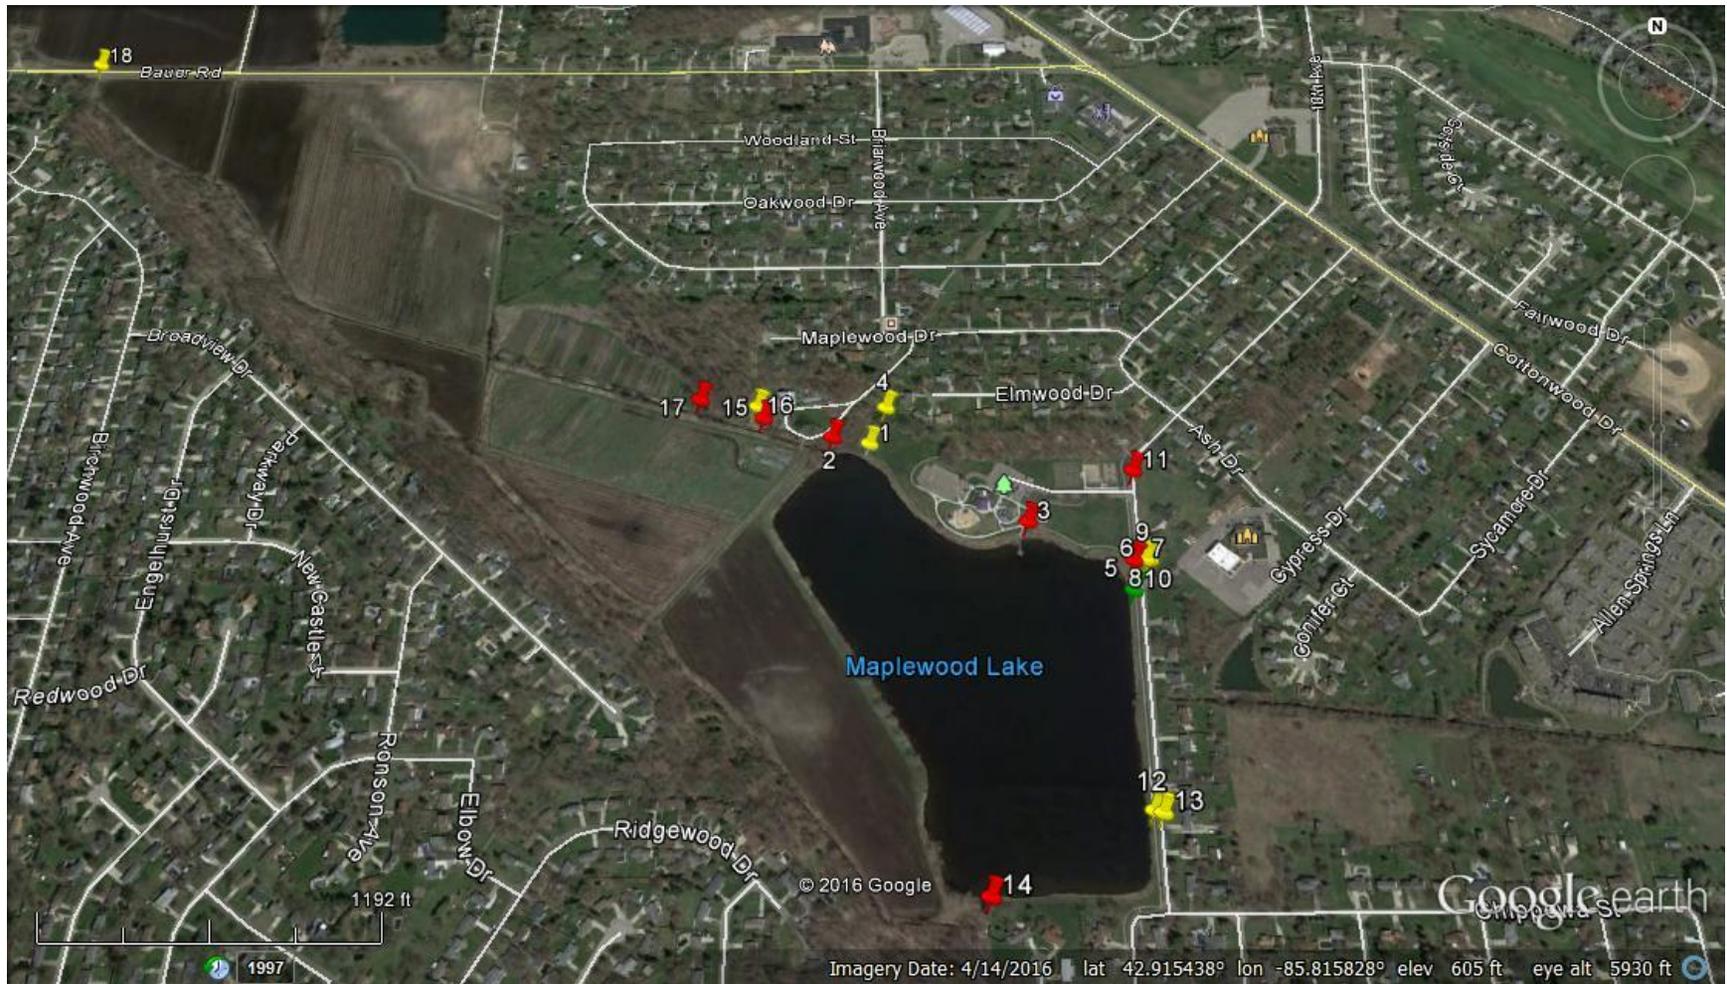
A spreadsheet of the canine field investigation results is presented on page 5 and a Google Earth image of the results is presented on page 6.
