REPORT OF CANINE INVESTIGATION OF HUMAN WASTEWATER CONTAMINATION

Maplewood Lake, Jenison, MI

Prepared For: Georgetown Township, MI

Report Date: August 1, 2016

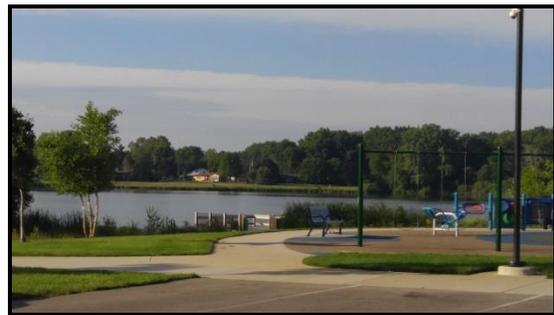
The investigations began by collecting water samples at three locations along the north side of the lake where E. coli testing is conducted on a regular basis. The samples were scent tested by

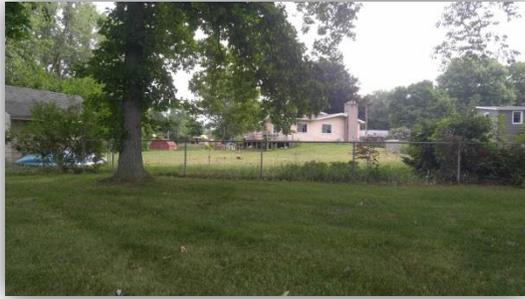
both ECS canines. Canine Sable alerted to the presence of human wastewater in the sample from the northwest side of the lake, directly downhill of two houses at the end of Elmwood Drive. Investigation of the park property along the back fences of those houses resulted in Sable alerting at a large patch of grass that was greener than the surrounding grass, next to the back yard fence of the house at the end of Elmwood Drive

and showing interest in scent in the air coming from the back yard of the house. Both canines alerted on the samples collected from the creek outfalling to the lake at the northwest side of the lake and also at next to the dock towards the northeast side of the lake.

- If a house or building is on a septic system, this needs to be investigated to find out the age, size, and use of the system and how it has been maintained. Any system older than 20 years is suspect, and even less than that if it has not been maintained. An examination by a professional to determine whether the system is failing and needs to be repaired or replaced may be needed. The Health Department may be able to assist with this.
